CHALLENGE OF DEVELOPING GROUND WATER PROJECT ALONG FAULT LINE

FEATURING BOERA GROUND WATER PROJECT PORT MORESBY , PAPUA NEW GUINEA

Senior Geotechnical Engineer
Mineral Resources Authority
Papua New Guinea

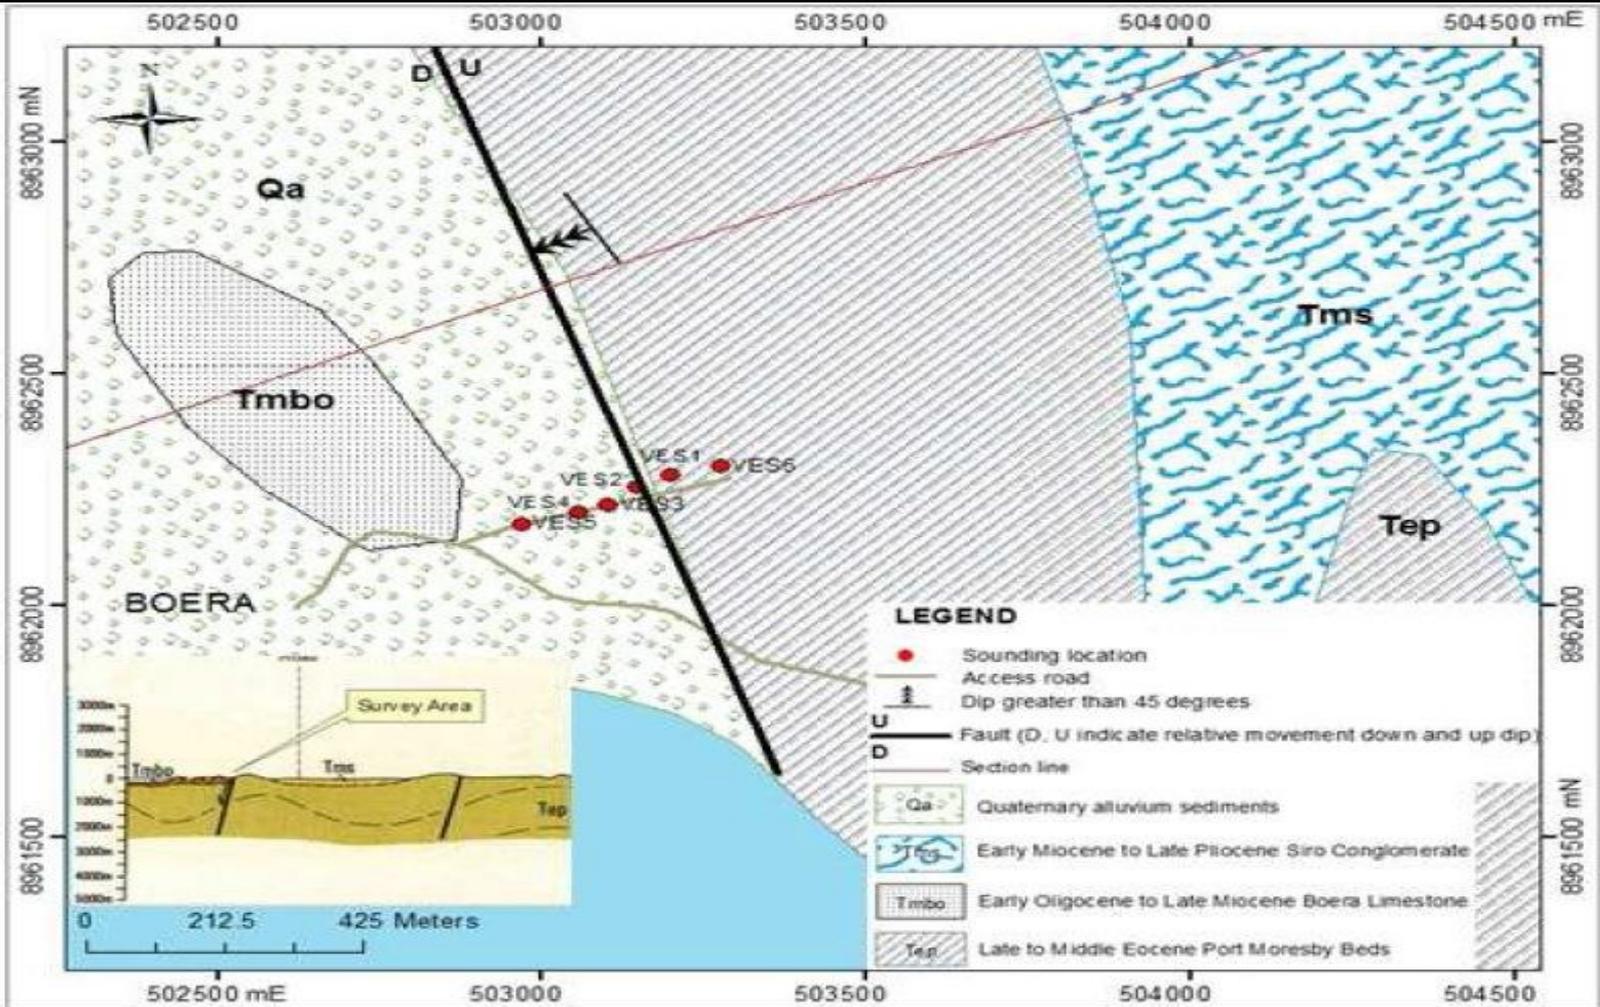
Project Site Geology

Figure 2: Geology map of survey area, after Pieter's (1978). Insert: A segment of section AB from Pom-Kalo-aroa 1:250K Geological Sheet.

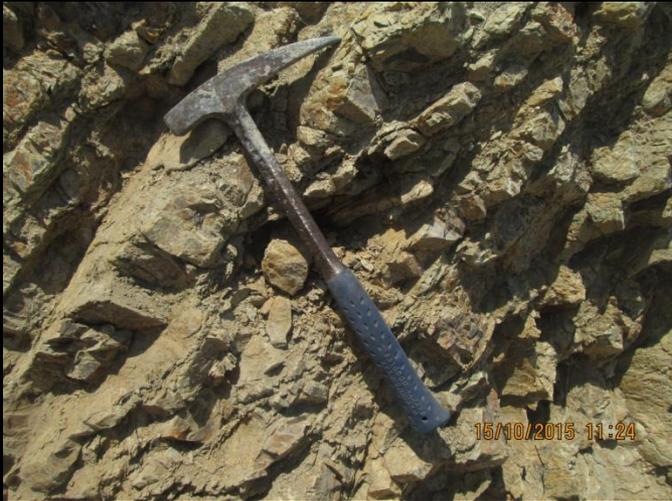
Mudstone: It is well-bedded, closely-fractured and jointed with abundant calcite veining. The unit is well-exposed in coastal exposures at Koki, Konedobu and Baruni, Boera. It is the most common rock unit in Port Moresby.

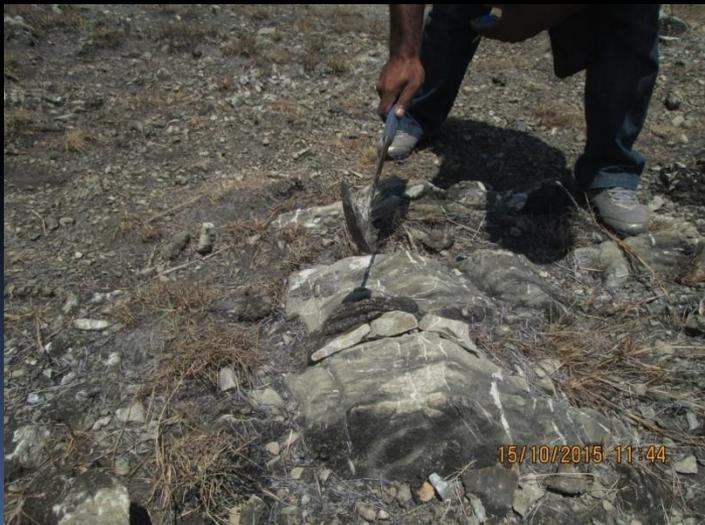
Baruni Limestone - fine-grained massive to well-bedded, hard and competent but closely-fractured and jointed. Exposures of this unit can be seen at Baruni, Kila Kila and other parts of Port Moresby.

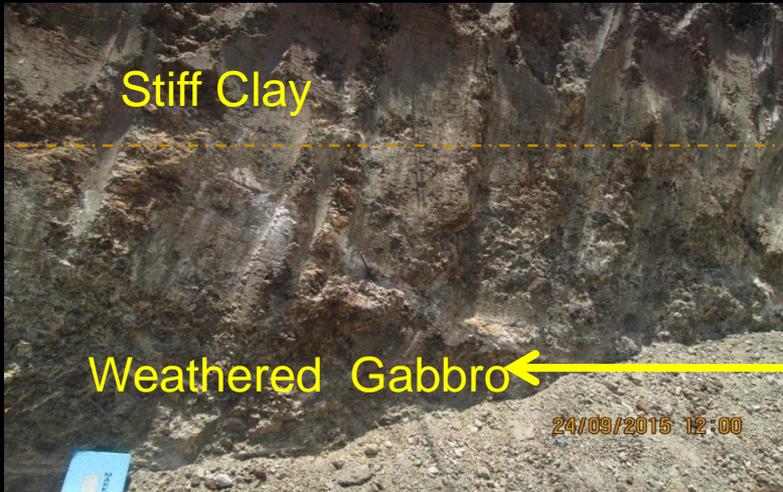
Sadowa Gabbro -medium- to coarse-grained. It is hard and competent when fresh but highly weathered exposures readily disintegrate to a sandy silty gravel. (Potential Source of Aquifer)

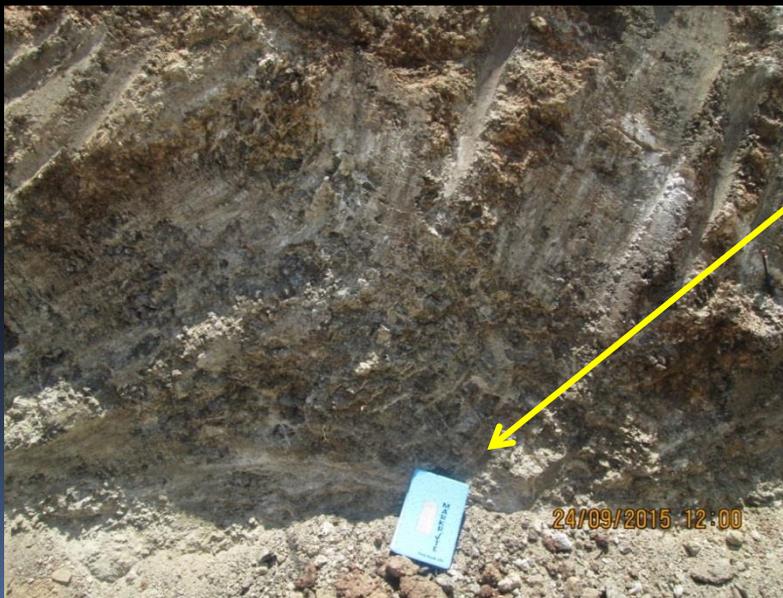
Highly weathered Gabbro overlain by the Stiff Clay along Gerehu -9Mile Highway, Port Moresby

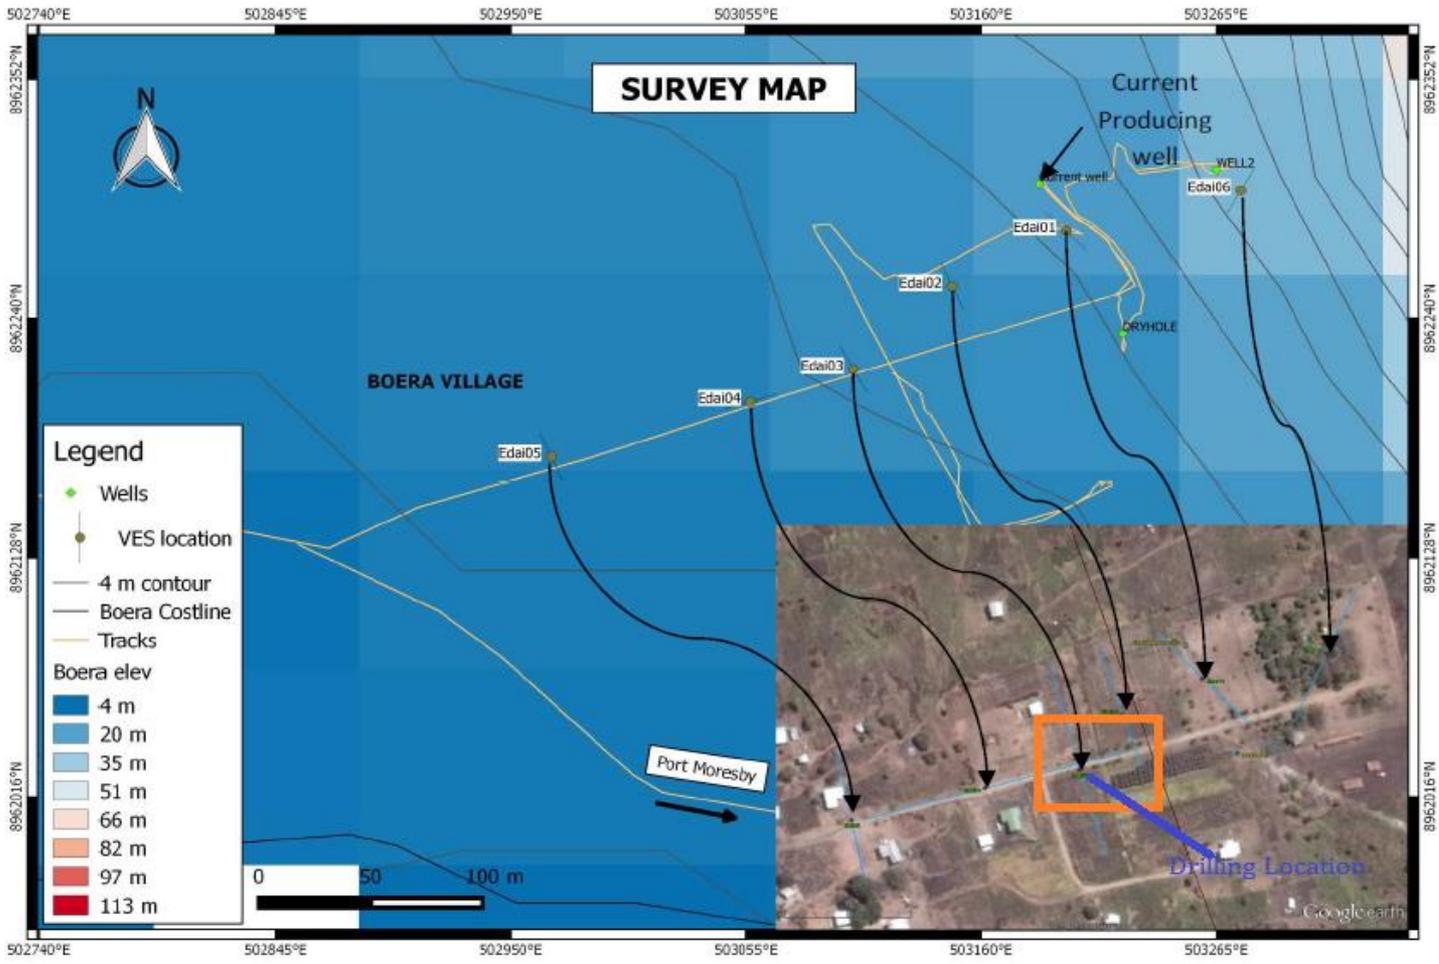
Geophysical Survey – Site Layout

- Conducted 6 vertical resistivity soundings over a site covering approx.100 square meters
- 300m away from the damaged bore hole.

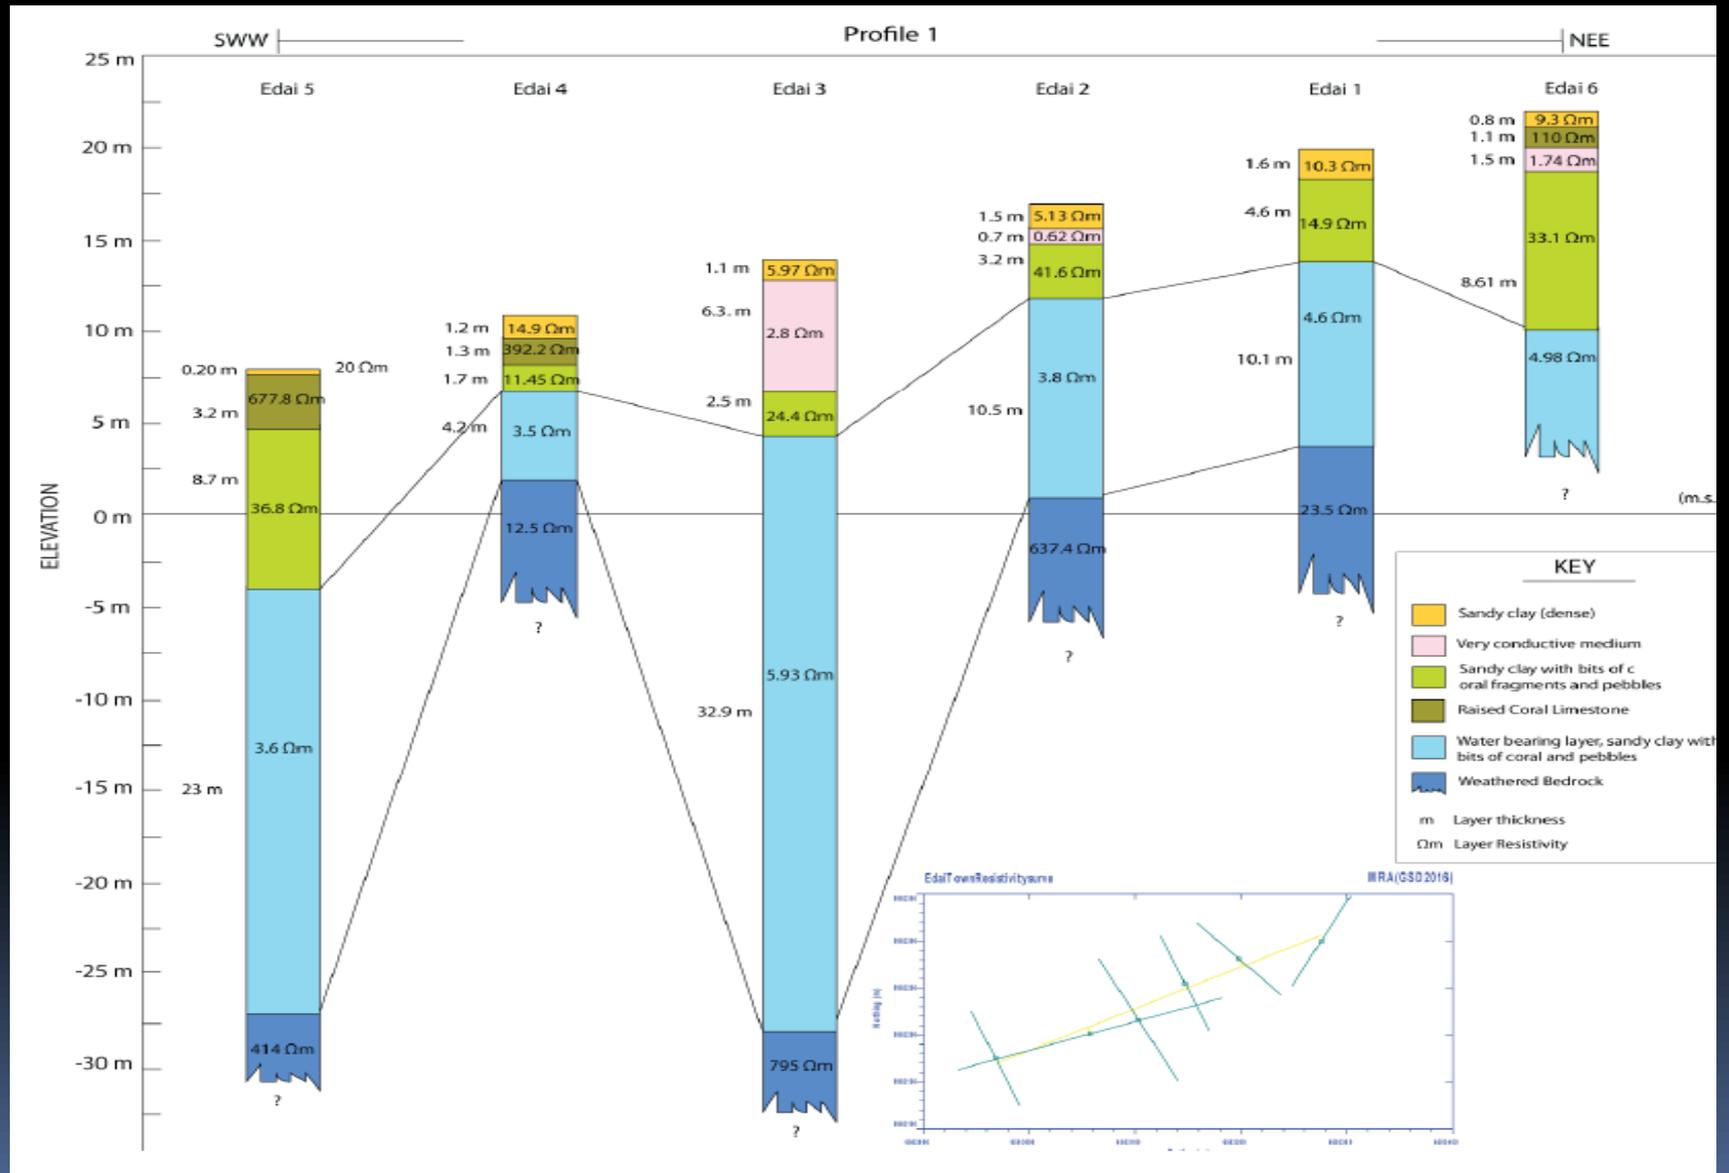
1-D Resistivity Model of Site

VES Station	Aquifer thickness (m)	Aquifer resistivity (Ω)	Depth to Groundwater Table (m).From surface	Elevation (m)
Edai1	10.1	4.6	6.2	13.81 → 3.76
Edai2	10.5	3.8	5.4	11.64 → 1.18
Edai3	32.9	5.9	9.8	4.20 → -28.65
*Edai4	5.1	3.9	3.6	6.72 → 2.53
Edai5	23	3.6	12.1	-4.1 → -27.0
*Edai6	?	4.9	11.9	18.66 → 10.05

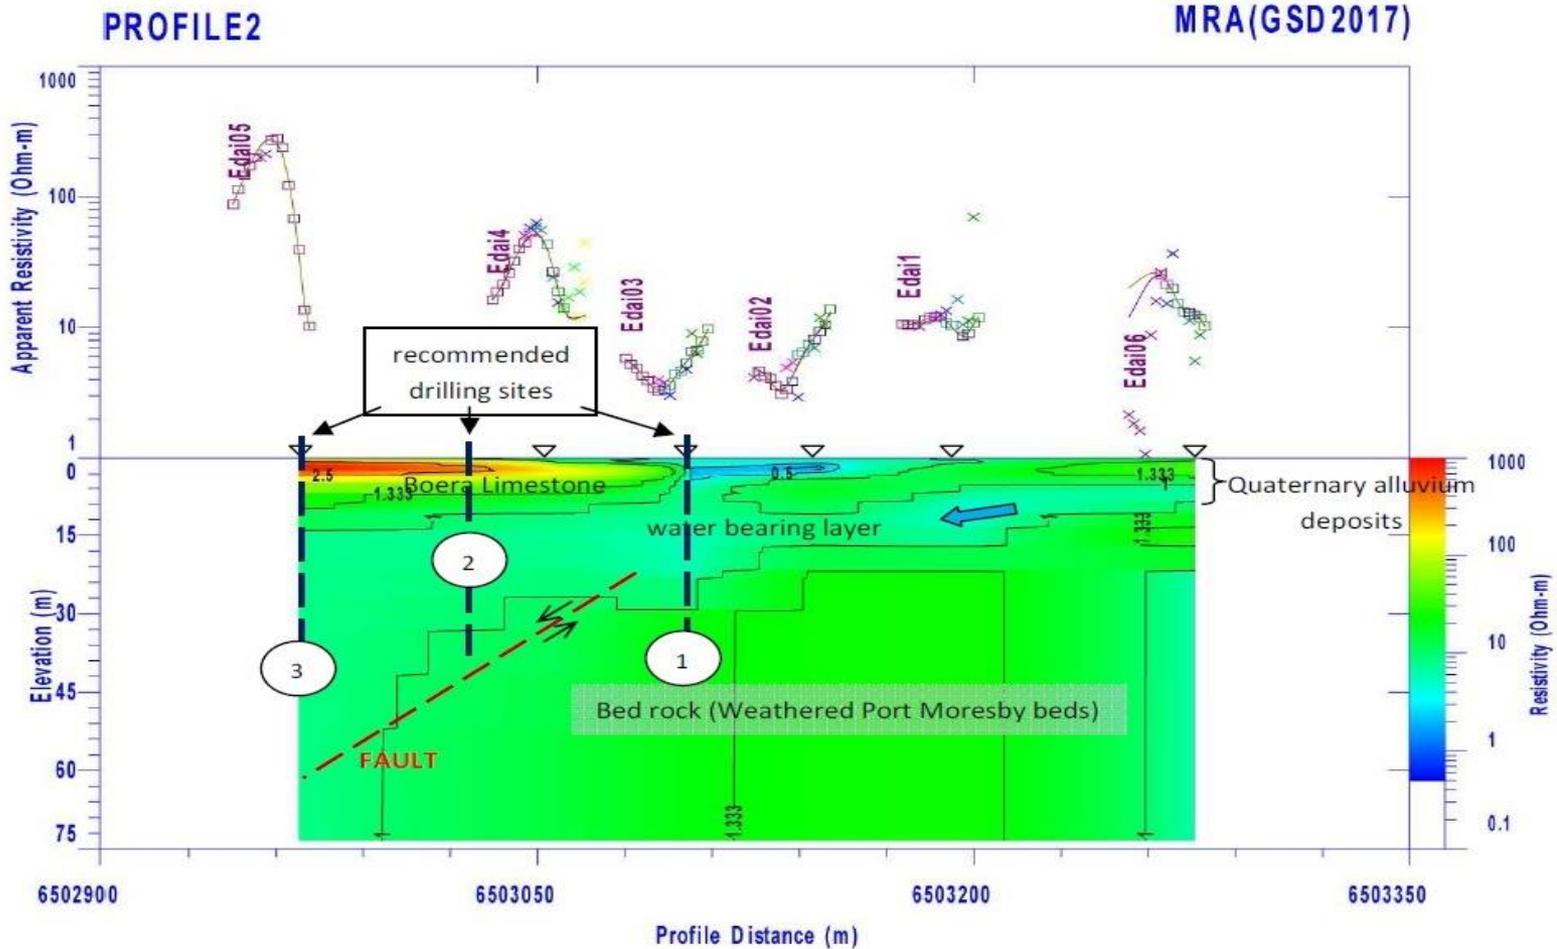
Cross Section – 1D Section Resistivity Line

Figure 6: Graph showing resistivity 1D-section through Profile 1. The Top half of the figure shows the Zarbovsky plot of the apparent resistivity curve while the bottom half is the resistivity 1D section along profile 1.

- From the geophysical survey, 2 possible sites were selected purely based on the following criteria;
- A fault detected from the resistivity survey and confirmed from the existing 50K geological series.
- (1) Good aquifer thickness (Eddai 03 =32.9m(Eddai05 25m)
- (2) Located on the footwall of a fault line NNW, SSE 45 (previous bore was located on the hanging wall of fault).
- Naturally water would flow from a high elevation to low elevation.

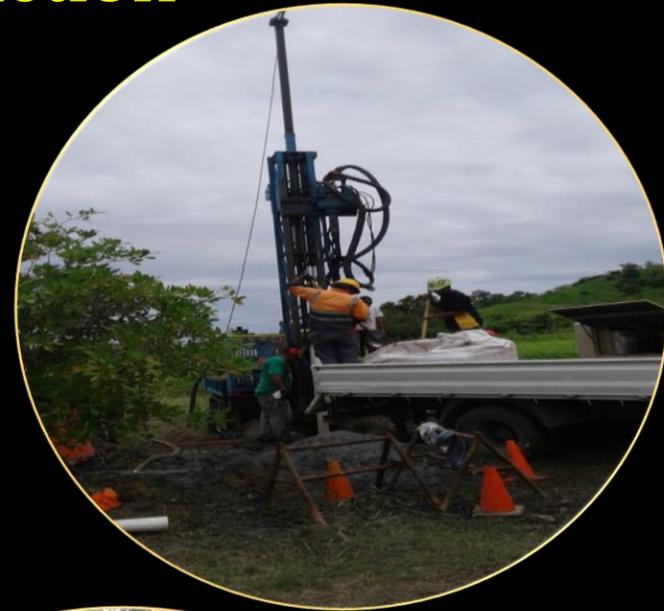
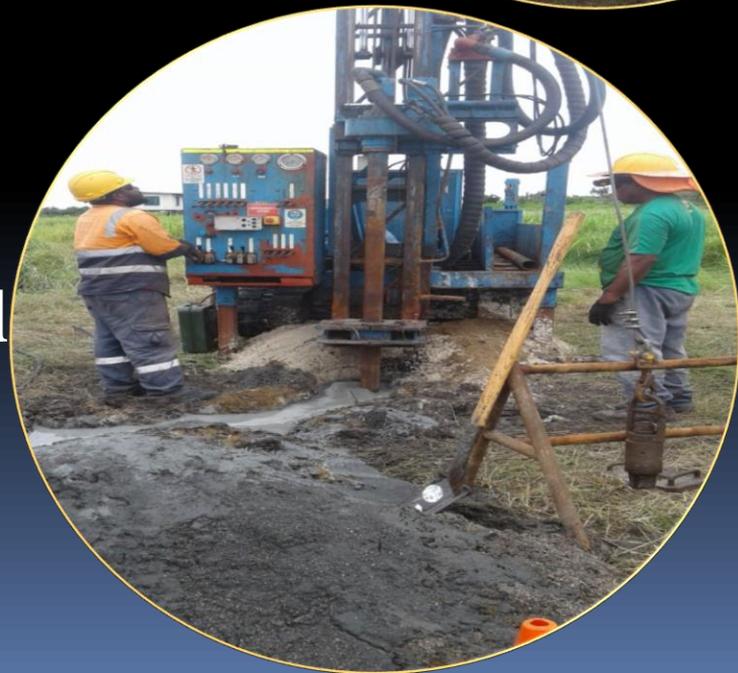
- Drilling was done using Multitec 9000 tractor mounted RC drilling rig. With compressor unit mounted on a truck.
- 700L support water tanker, 4 1/2 inch submersible pump
- 300mm open hole drilled depth to 30m (EOH)
- Cased with 150mm PVC casing

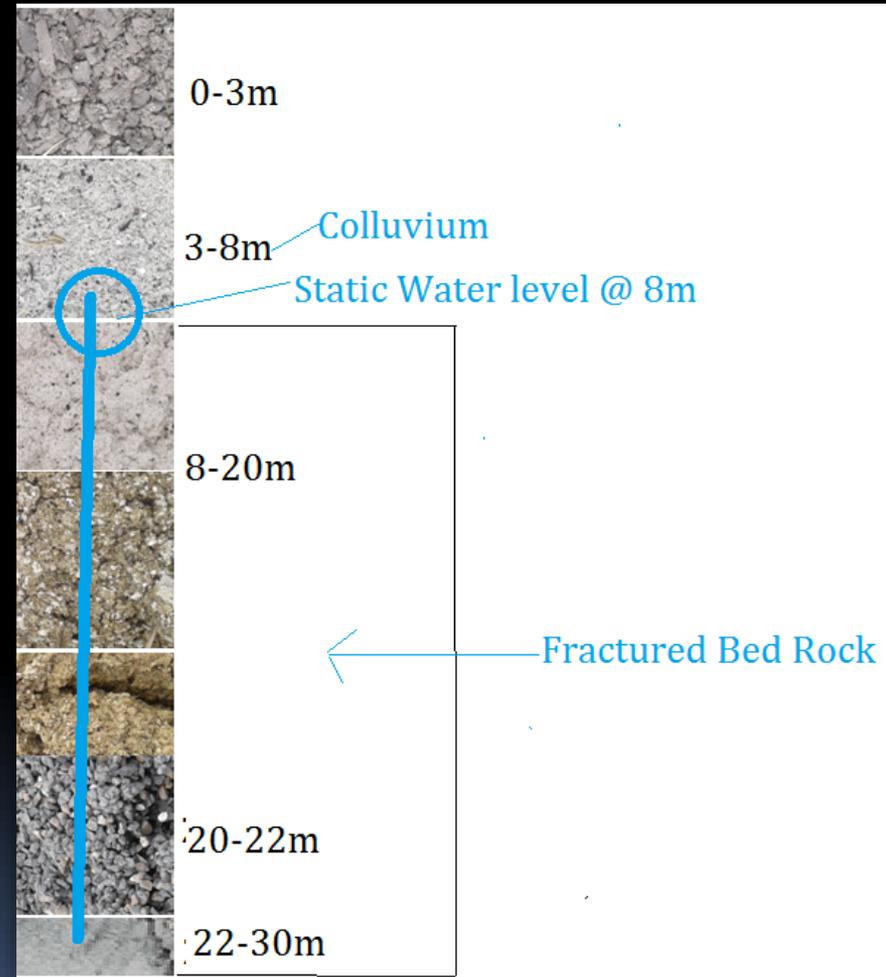
Sub-surface Profile

- ✓ 0-3m- Top Soil (Greyish black)
- ✓ 3-8m- Gravel – White grading to brown, some pieces of coral limestone (lagonal deposit)
- ✓ Fluctuating water table at 5-7m (gravel , sand, and silt , colluvium)
- ✓ Water strike in at 8m (Static water level measured from Probe) ,
- ✓ 8-20m – Limestone , extremely weathered
- ✓ 20-22m- Gabbro Sill, highly weathered (Water still present at this depth)
- ✓ 22-30- Mudstone grey grading to blue, highly fractured . (due to faulting)

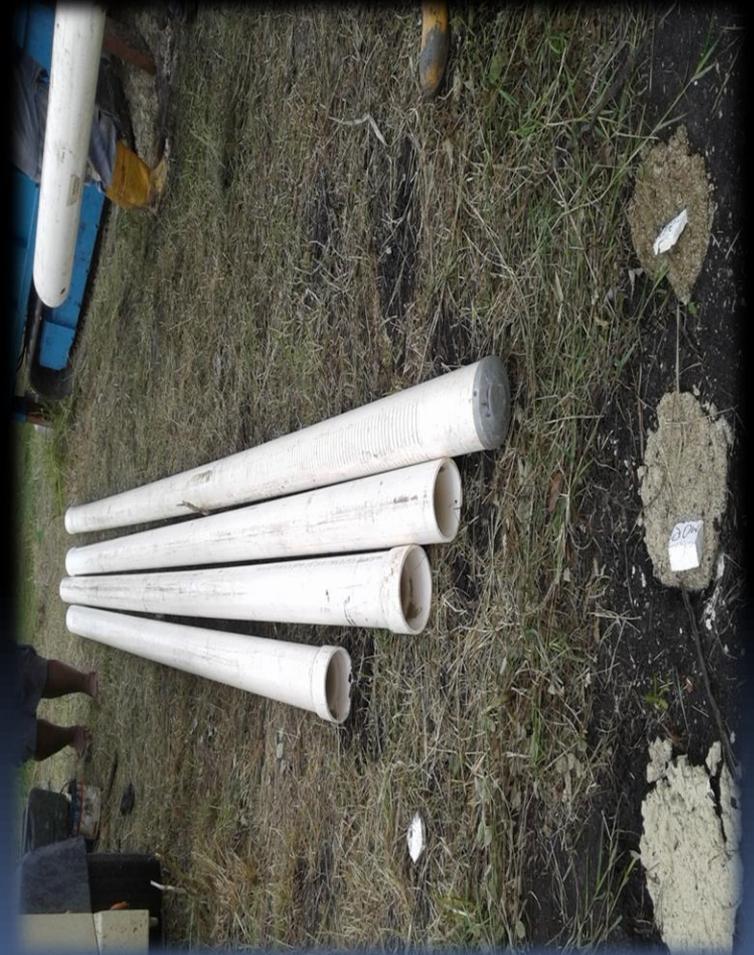
Well Construction

- A well was constructed with A 150 mm PVC screen placed into the bore hole suspended at 26m.
- Total of 6m in length
- Gravel was used for grouting the bore hole. (space between formation and casing)

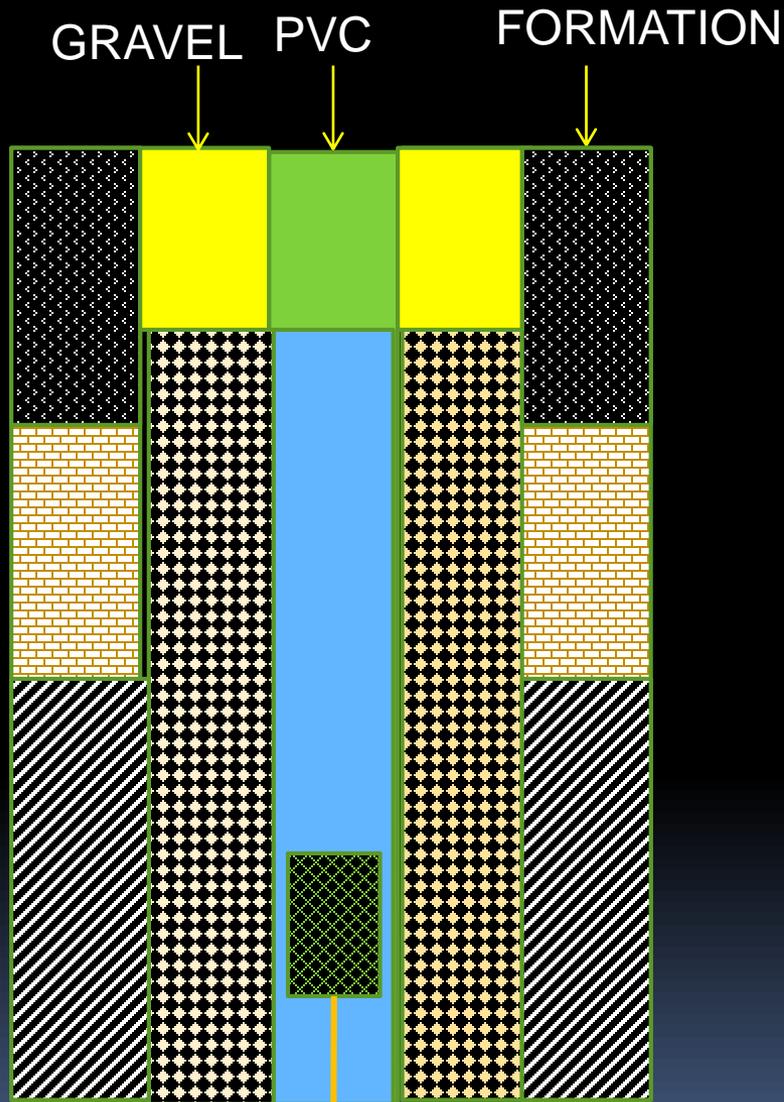
Well Construction Layout

Perforated Screen
(6m) suspended at 23m

Gravel pack @ 30m

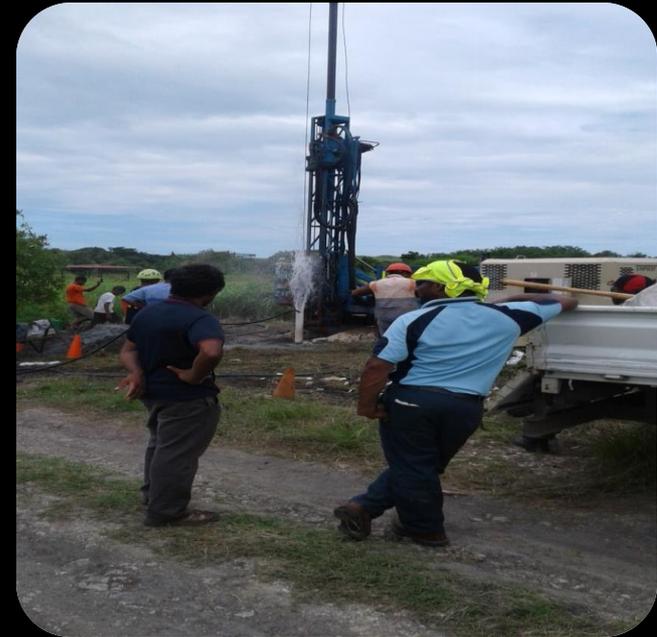
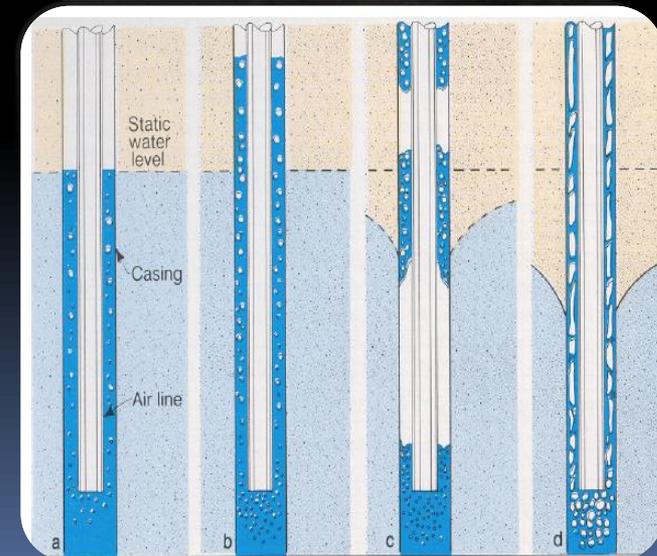
The well was developed using air lift surging purposely to;

- Remove fines to enhance well efficiency
- Optimize specific capacity
- Stabilize formation and limit sand production .

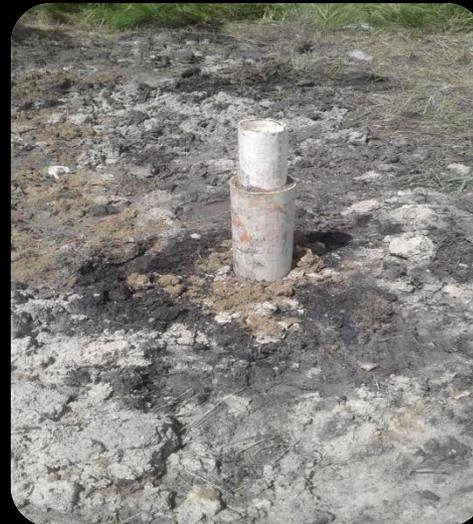
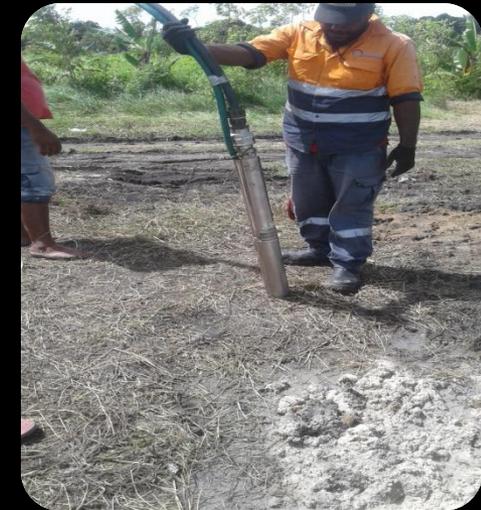
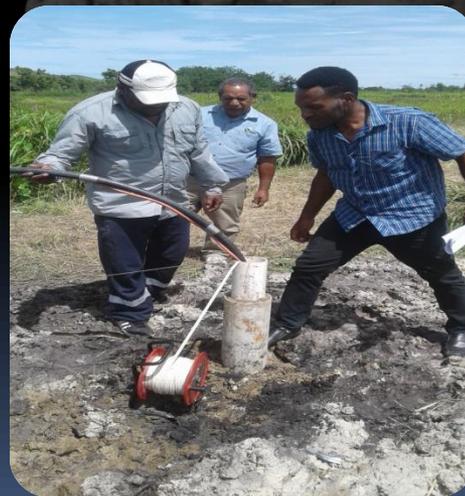
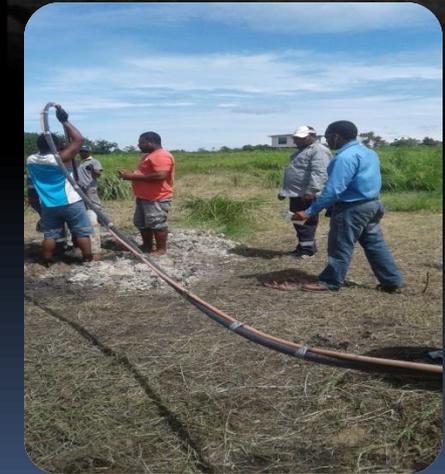
Aquifer Testing

- The Bore hole was tested at maximum constant discharge rate of 2/L sec for 24hrs and draw done of 4m.
- After 24hr test, the standing water level was maintained at 9-5-10m

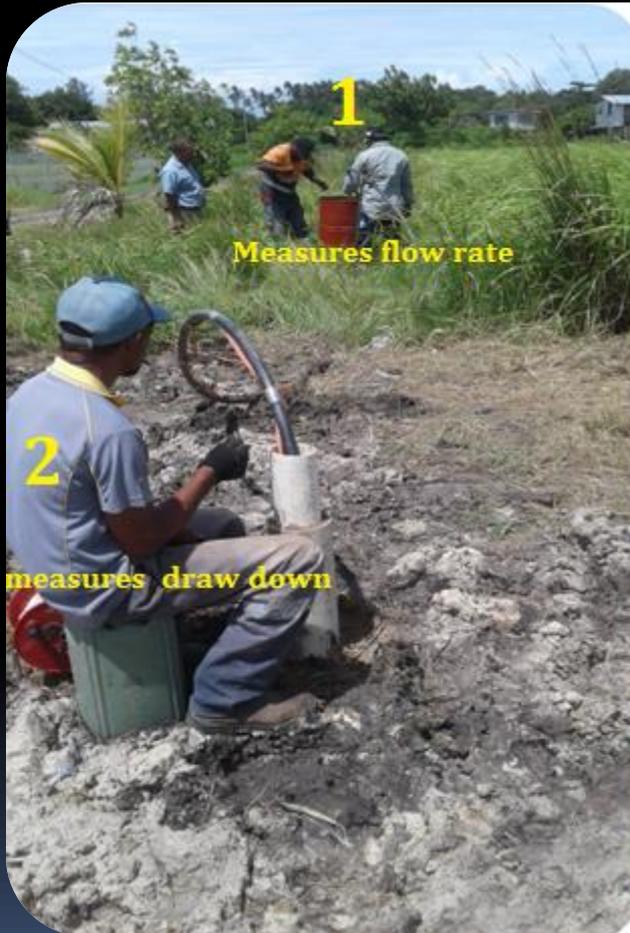
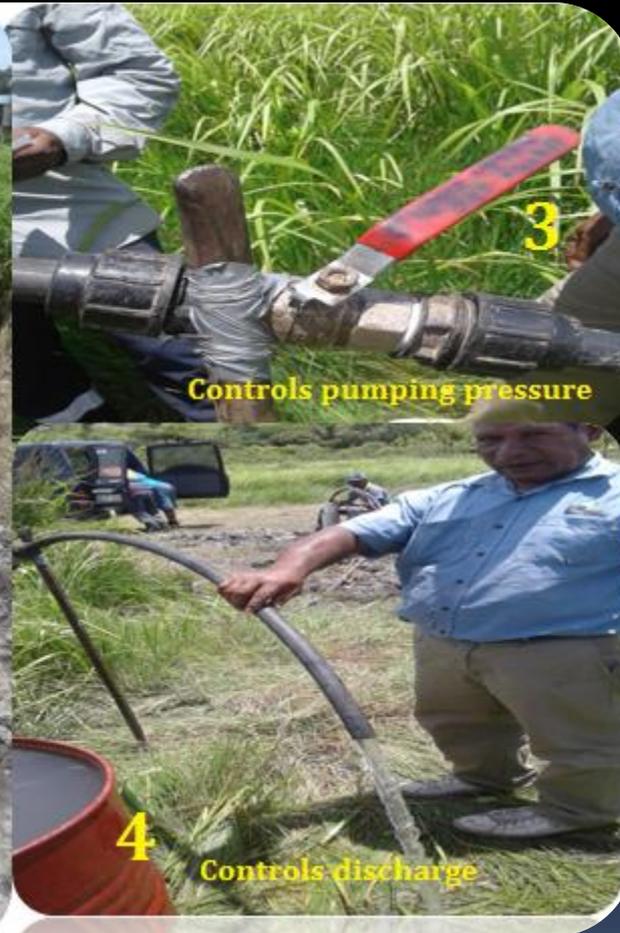
Pump Testing

- A pump test was conducted over 24hrs.
- A draw down of the well was measured
- Within of 24hrs test period water level was maintained at 9.32 10m
- Bore well yield (flow rate) measured is about 2L/s

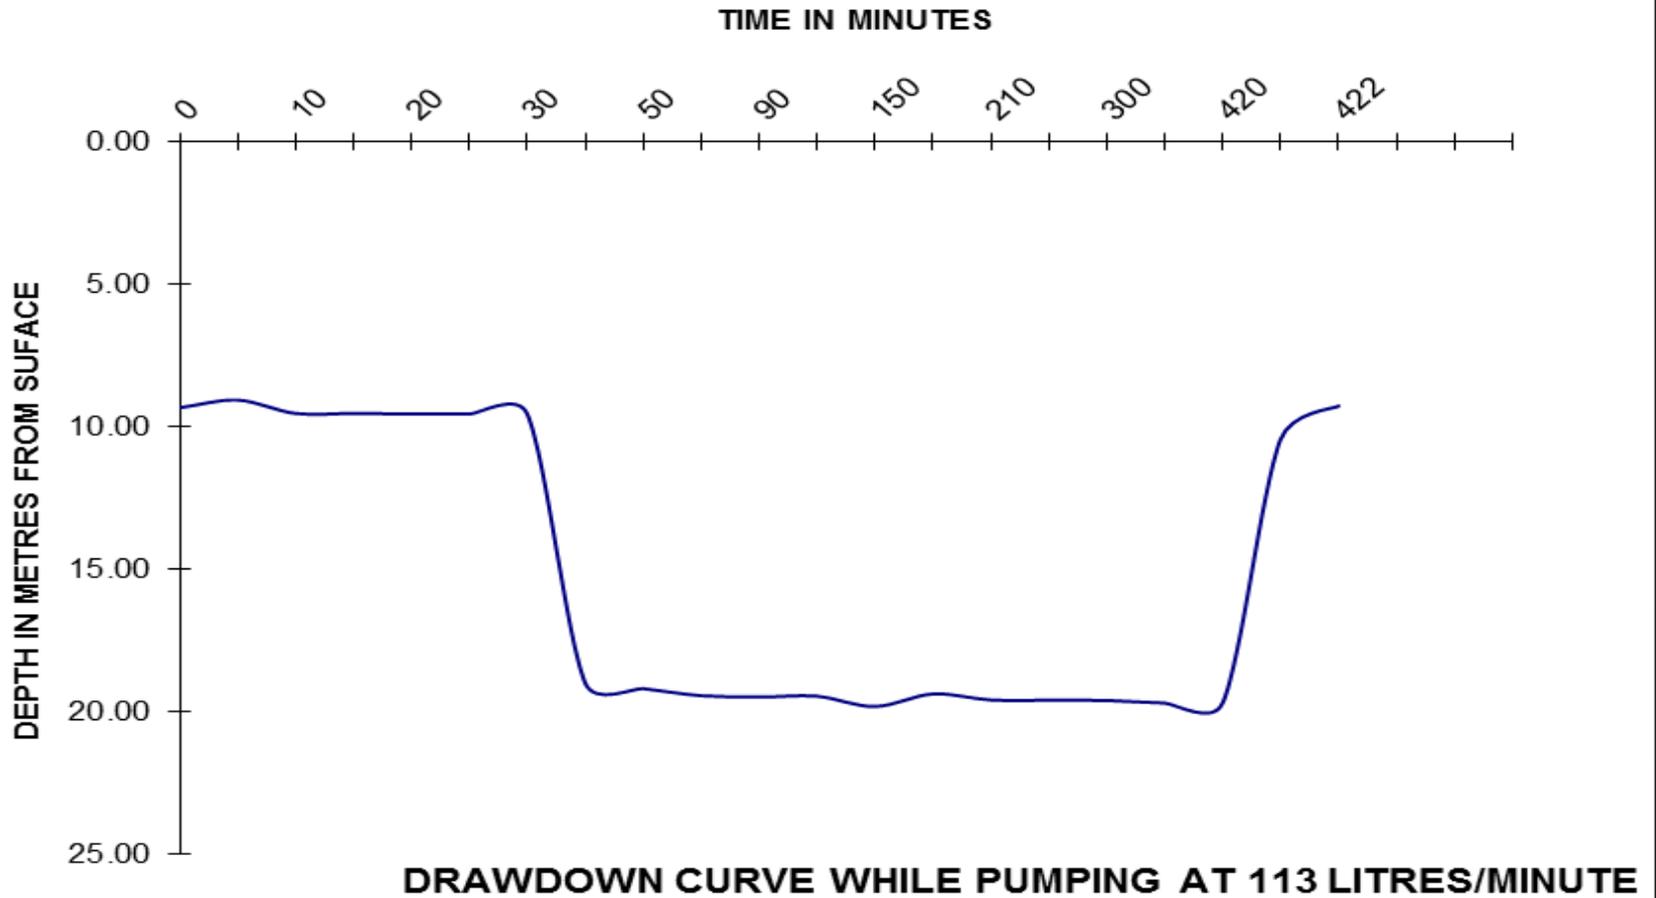
Draw Down Curve while pumping

TIME (m)	WATER DEPTH (m)
0.00	9.32
5.00	9.05
10.00	9.52
15.00	9.52
20.00	9.54
25.00	9.54
30.00	9.54
40.00	18.99
50.00	19.18
60.00	19.43
90.00	19.48
120.00	19.45
150.00	19.81
180.00	19.37
210.00	19.58
240.00	19.59
300.00	19.60
360.00	19.69
420.00	19.69
421.00	10.43
422.00	9.26

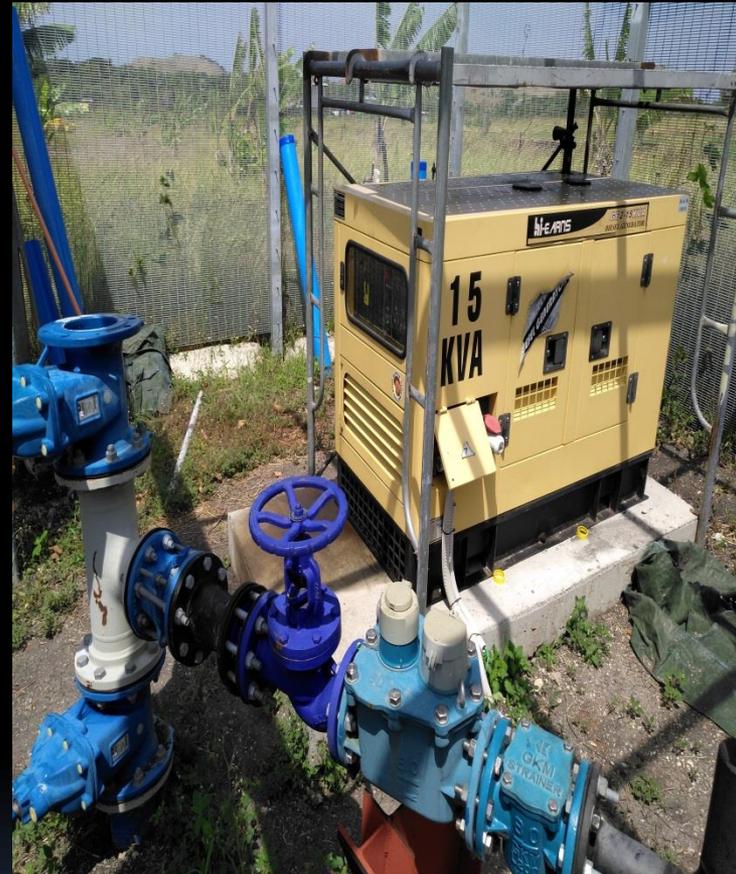
- The bore pump discharge rate was set at 113 litres per minute with the pump at 23 meters. The pump was shut down at 420 minutes and the bore allowed to recharge .
- Based on the timer taken for the full recharge from ceassation of pumping , the bore hole is able to sustain a continual pumping rate of 113L per minute , 6780 litres per hour and daily yield (24hr) of 162, 720 litres

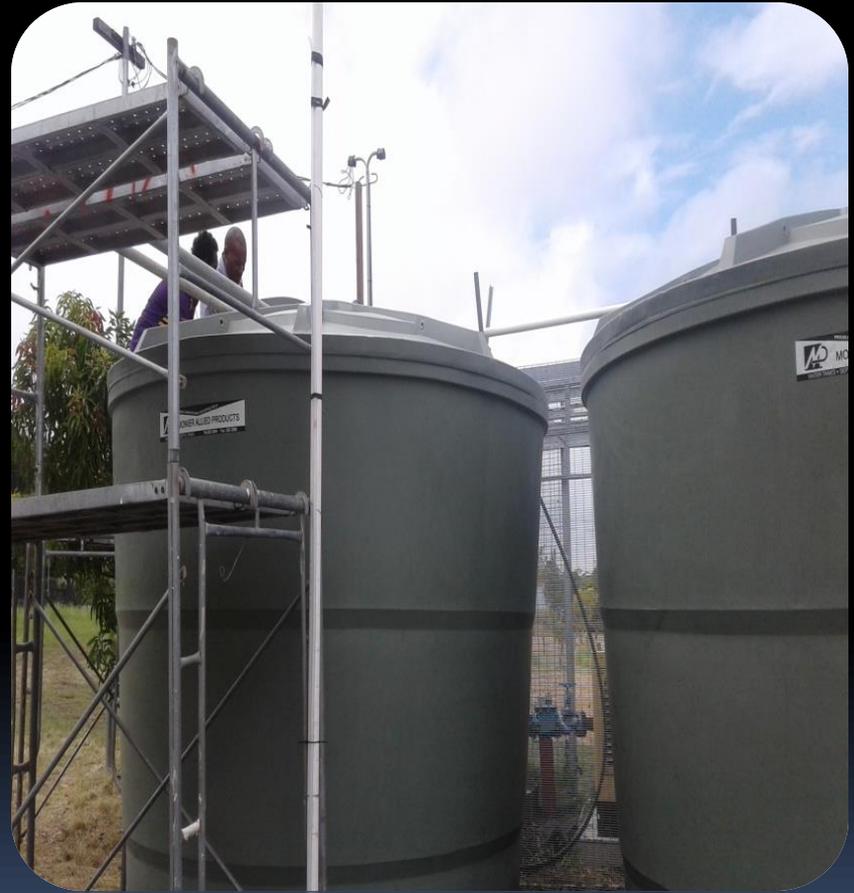
- Water is been pumped out of the bore hole to pump out facility located 200m away from test bore well.
- 2x15000L reservoir tanks filled to capacity and pumped out at 1.56L/s to Eddai Town.

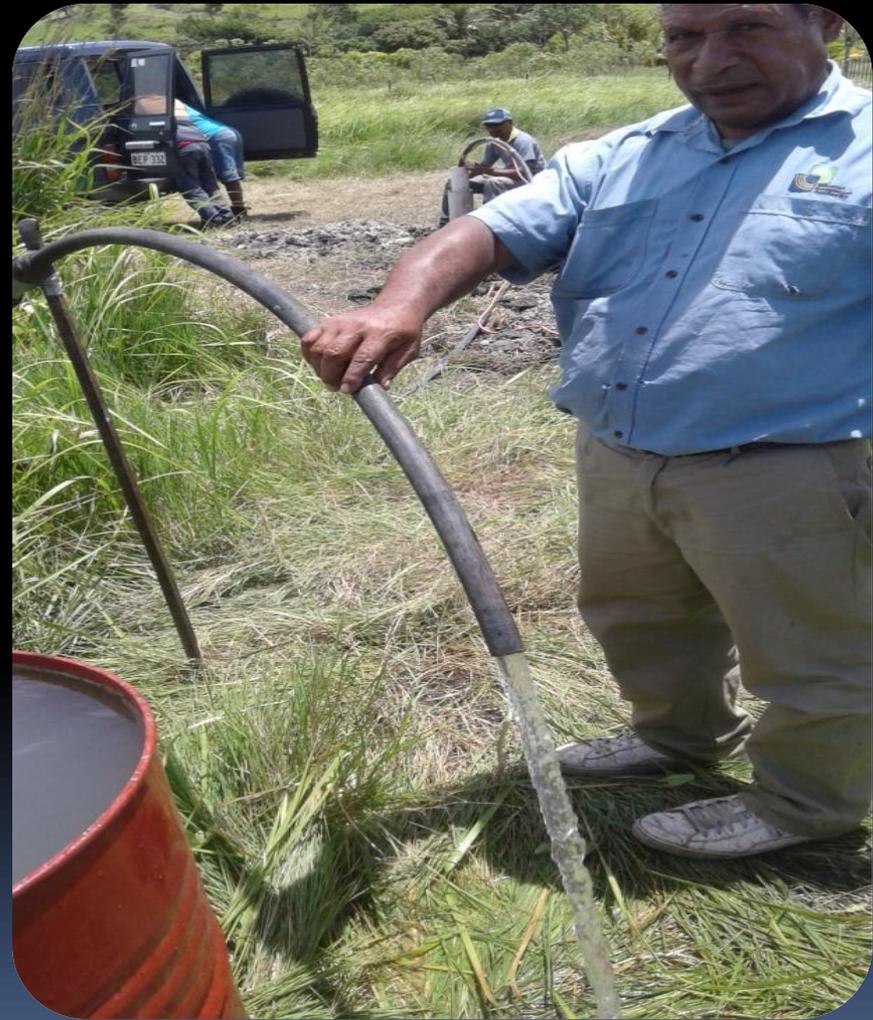
- Water quality test were conducted to check for presence of;
 - *Total Coliform*
 - *E. Coli*
 - *Faecal Coliforms and other*

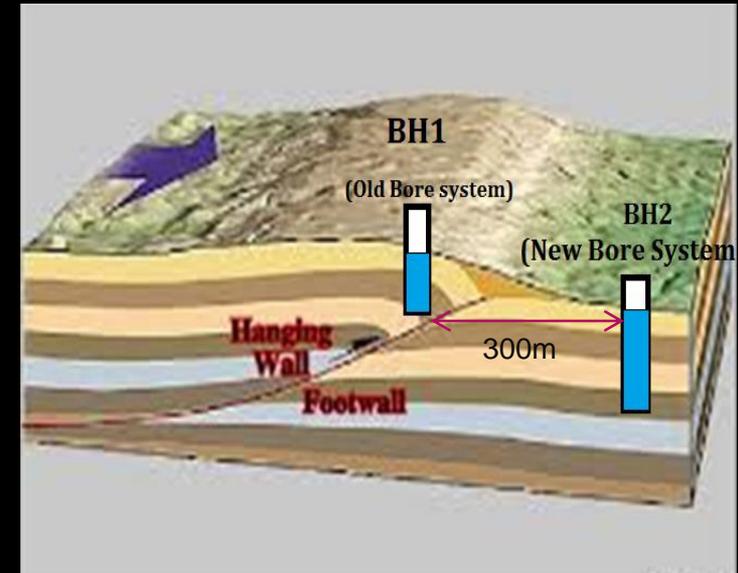
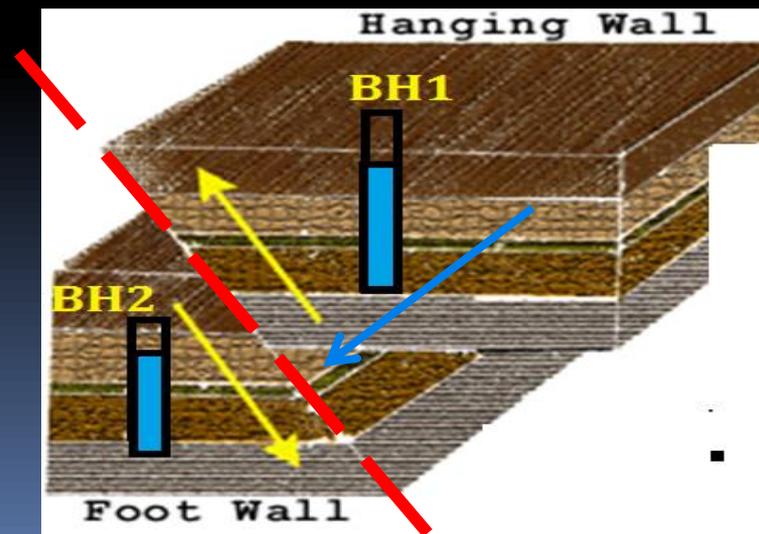
Site Selection for Drilling

- From the geophysical survey, 2 possible sites were selected purely based on the following criteria;
- A fault was detected from the resistivity survey.
- (1) Good aquifer thickness (Eddai 03 =32.9m(Eddai05 25m)
- (2) Located on the footwall of a fault line NNW, SSE 45 (previous bore was located on the hanging wall of fault).
- Naturally water would flow from a high elevation to low elevation.
